Investigation of Vilnius Upper Castle Vertical Deformations

Abstract. The aims of this study were to review the monitoring methodology of the vertical deformations and to identify the reasons of deformations that occur in structures of Vilnius Upper Castle, Lithuania. Collected systemized data is processed with mathematical–statistical methods. In order to investigate the state of the buildings, a new cycle of measurements (XIV) was carried out in 2016. Data of all measurement cycles is presented and compared with previous data that was provided in technical reports of measurement cycles (first measurements began in 1968). In order to investigate conditions of the structures, data is presented graphically. When analyzing the graphics, it is possible to investigate changes of the buildings and possible causes of their appearance are presented. Long-term research and results have shown, that all the cracks and crevices that were found during monitoring (1968 to 2016) in Upper Castle’s structures were caused by large and uneven deformations.

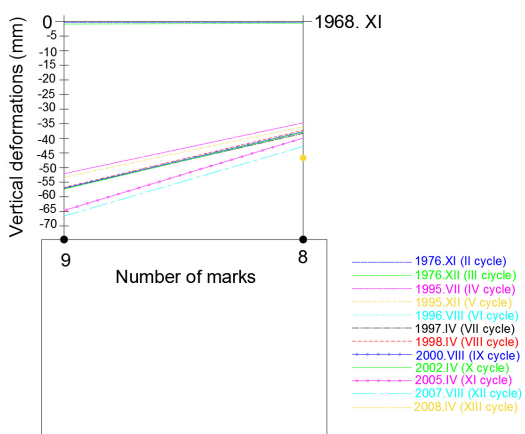
During the second last cycles data (2008), on average, most of the vertical deformations of the structures were established in foundation of the Southern Tower (46.7 mm) and the least at Northern Wall (11.7 mm) using data from November, 1968 (40-years period). The biggest vertical deformation was established of the mark Num 5627 (at Grand Duke Palace) – 59.3 mm, the lowest of the mark Num. 5630 (at Grand Duke Palace) – 10.8 mm. Within 13 years since December 1995 the biggest average vertical deformation was detected on Southern Retaining Wall (21.8 mm) and the

Fig. 2. Vertical deformations of foundations of Southern Tower

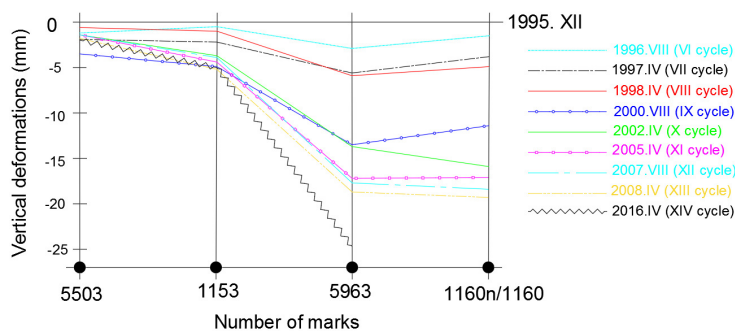
lowest – at Northern Wall (5.1 mm). Southern Retaining Wall’s mark Num. 9455 vertical deformation during data of measurements was the biggest – 41.0 mm and the East Retaining Wall’s mark Num. 19n/5207 contrariwise – 0.9 mm.

Fig. 3. Vertical deformations of Eastern Retaining Wall

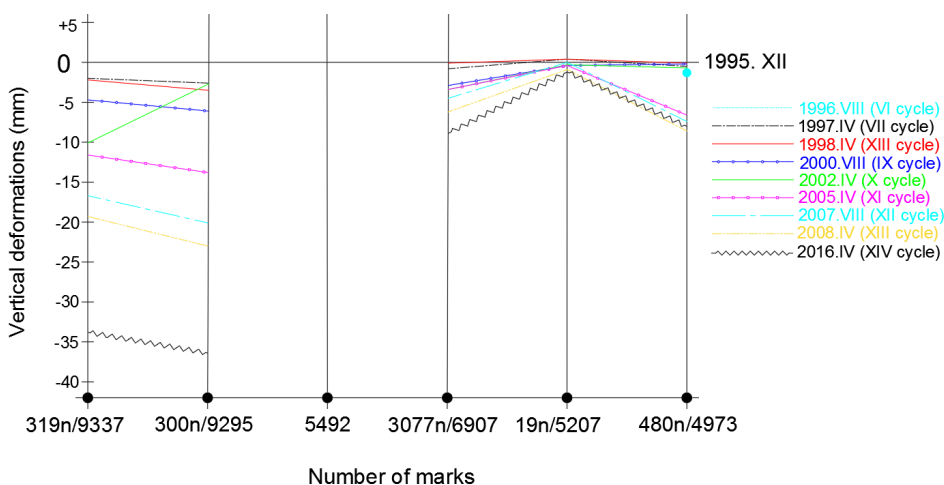
Fig. 4. Vertical deformations of Southern Retaining Wall

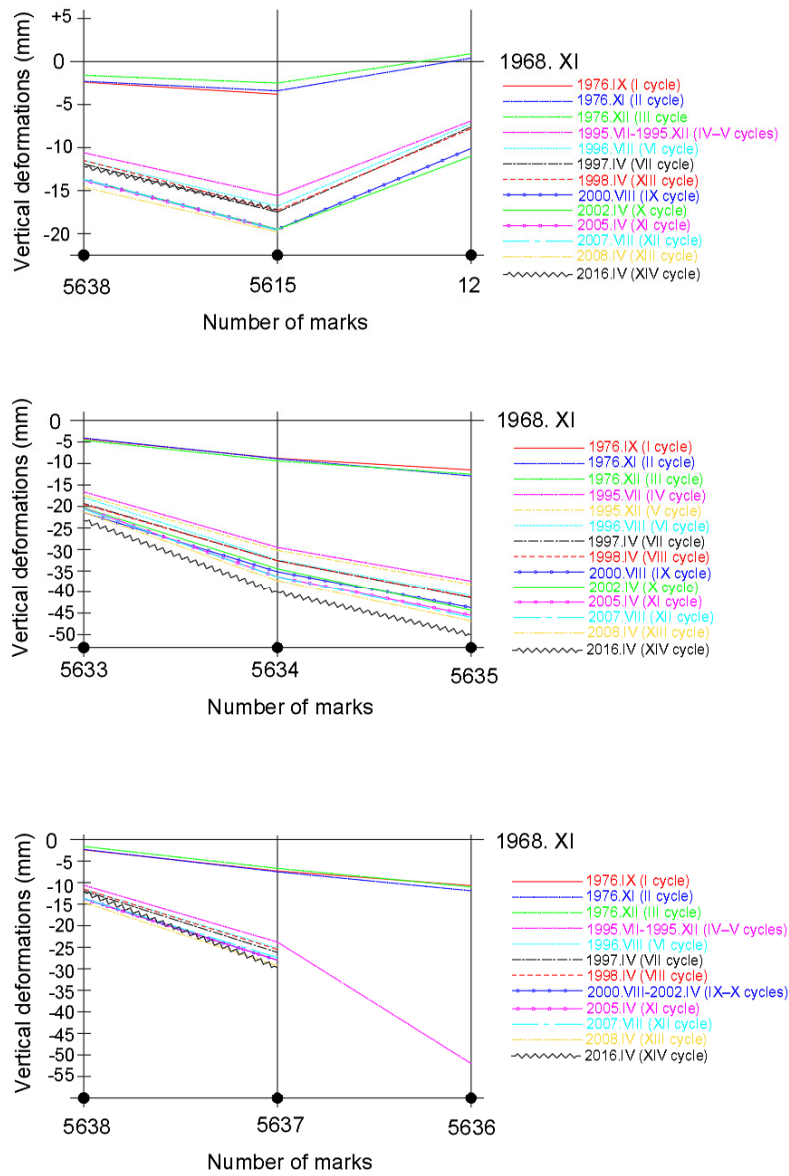
Comparing all data (from November 1968) with the data of the last cycle in 2016 (48-years period), most average vertical deformations were established at Grand Duke Palace (35.2 mm), Gediminas Tower and a part of Southwestern Defensive Wall (28.7 mm). Foundation of the Southern Tower has not been recorded due to the corrosion of marks. The biggest vertical deformation during period since 1968 was observed at Grand Duke’s Palace mark Num. 5627 (73.3 mm); the lowest 8.1 mm of mark Num. 5630. Since December 1995 (21-years period) the biggest average vertical deformation was detected on Southern Retaining Wall (26.4 mm), the lowest – 10.6 mm of Southwestern Defensive Wall (near Gediminas Tower), the vertical deformation of East Defensive Wall on average was 17.7 mm. South Defensive Wall’s vertical deformation value (48.7 mm) was established of the mark Num. 9270; the lowest – of the mark Num. 19n/5207 (East Defensive Wall) – 1.2 mm.

Fig. 5. Vertical deformations of Gediminas Tower and a part of Southwestern Defensive Wall

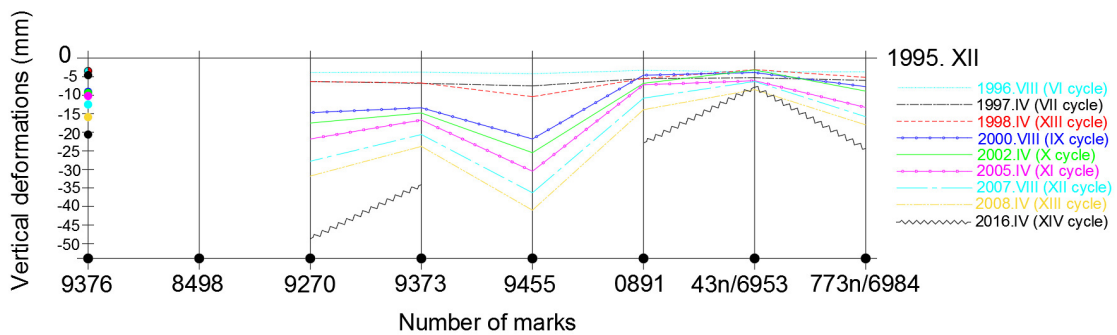
Fig. 6. Vertical deformations of Southern Defensive Wall

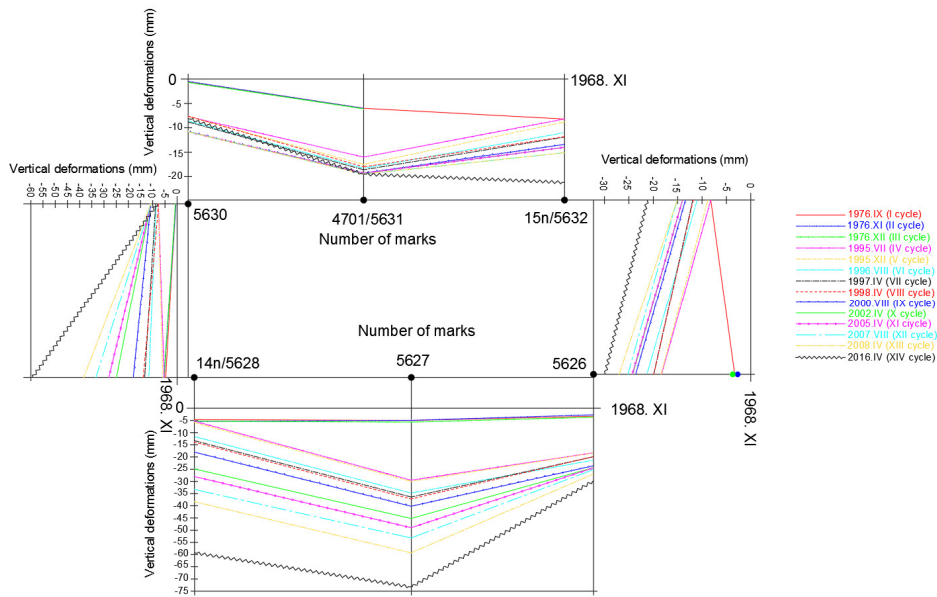
Fig. 7. Vertical deformations of Grand Duke Palace

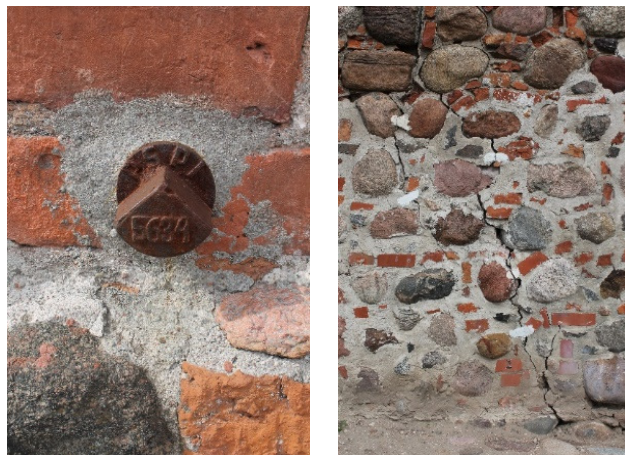
The whole area was inspected carefully and 26 marks have been found around the Upper Castle. One of the Gediminas Castle marks is shown in Figure 8. Visible cracks in the structures (Fig. 8, on the right) confirm about permanent deformations.

Fig. 8. Mark Num. 5634 on the left; on the right – visible crack on Grand Duke Palace

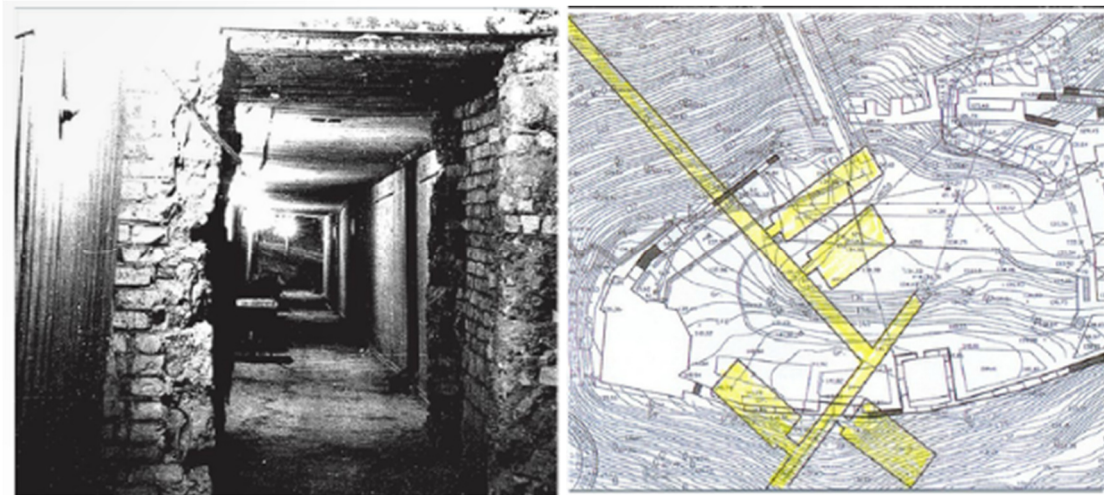
Steep slopes, plants, rotting stumps are causing erosion and landslides of the slopes. Several large landslides were mentioned in technical reports (a new landslide was recorded at the end of 2016), which probably influenced vertical deformations of the Vilnius Upper Hill structures. Poor draining, improperly performed works of slope stabilization, trample down vegetation areas, existing underground structures (tunnels and shafts). In the article of “STRUCTUM” magazine (Lekaviciene 2014), it was offered to analyse all previously collected information of Vilnius Upper Castle conditions when the threat has occurred. The article also reveals one of the secrets of Gediminas Hill – underground tunnels: mysteriously winding underground corridors entering premises, brick or wood lumber walls, in some places ceilings have wooden supports. Scheme of the tunnels and photos are shown in Figure 9. According to the head of the Public Enterprise “Lietuvos paminklai” V. Drumsta, underground tunnels were dug by prisoners of war during WW II. Condition of these tunnels is not investigated yet, but the fact is that effect exists. It is because of bad conditions of the overall underground structures. While searching for causes of failures and landslides of the hill, scientists raised hypothesis that the main issue is poor conditions of underground structures and failure of constructions (Lekaviciene 2014).

Fig. 9. Underground tunnels of Gediminas Hill (Lekaviciene 2014)
