Investigation of Vilnius Upper Castle Vertical Deformations

Abstract. The aims of this study were to review the monitoring methodology of the vertical deformations and to identify the reasons of deformations that occur in structures of Vilnius Upper Castle, Lithuania. Collected systemized data is processed with mathematical–statistical methods. In order to investigate the state of the buildings, a new cycle of measurements (XIV) was carried out in 2016. Data of all measurement cycles is presented and compared with previous data that was provided in technical reports of measurement cycles (first measurements began in 1968). In order to investigate conditions of the structures, data is presented graphically. When analyzing the graphics, it is possible to investigate changes of the buildings and possible causes of their appearance are presented. Long-term research and results have shown, that all the cracks and crevices that were found during monitoring (1968 to 2016) in Upper Castle’s structures were caused by large and uneven deformations.

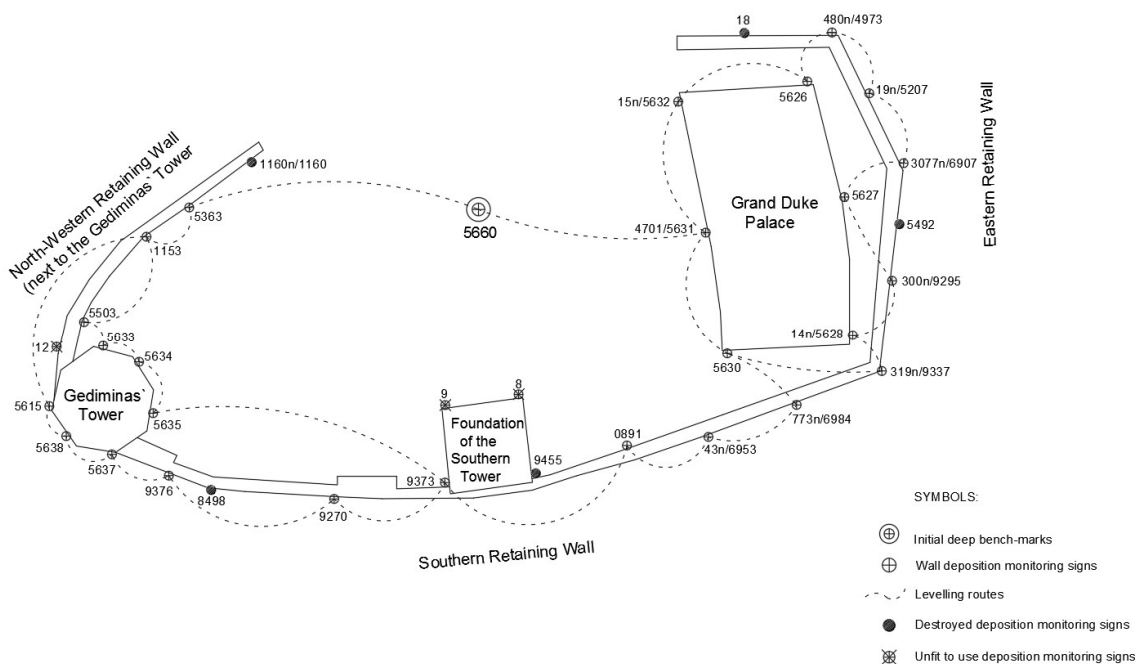
Fig. 1. Monitoring of geodetic marks of vertical deformation and levelling scheme on the 6th of April, 2016

The objects of the research are the Gediminas' Tower and a part of Southwestern Defensive Wall, Grand Duke Palace, Foundation of the Southern Tower, Northern Wall, Southern Retaining Wall, Eastern Retaining Wall and North-Western Retaining Wall (next to the Gediminas' Tower). During the cycle, it was decided to abandon monitoring of the Northern Wall deformations because of the negligible displacements of geodetic marks. It was also found, that using data from the technical reports of the long-term measurements, it is difficult to draw conclusions about the Northern Wall vertical deformations and tilting. Gediminas Upper Castle structure, geodetic marks of vertical deformations and levelling scheme are shown in Figure 1.
